Roanoke, Town of
(White Hotel)(Cillooly Hotel)
Roanoke
Lewis County
West Virginia

HABS No. WV-209-F

WRITTEN HISTORICAL AND DESCRIPTIVE DATA

ROANOKE, TOWN OF
(White Hotel)(Gillooly Hotel)

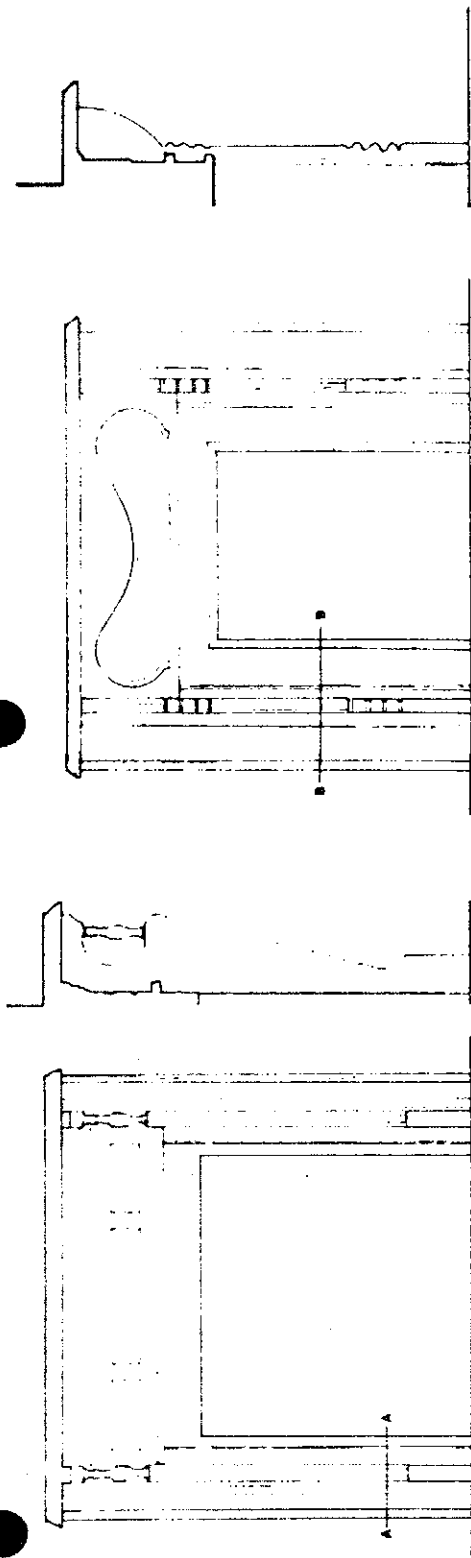
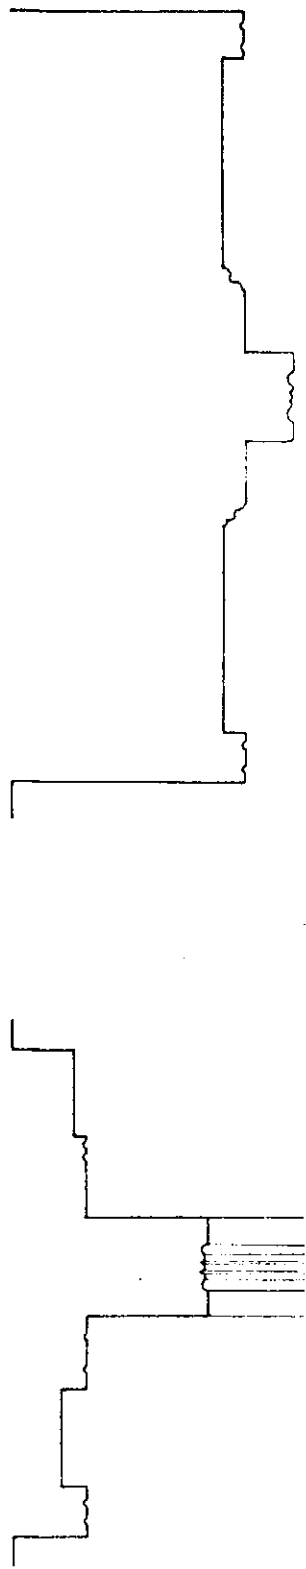
Mantle detail in Rooms 1, 2 and 10 of the White Hotel

Fireplace: brick; 2'9" wide x 3' high x 11 1/2" deep firebox; 47" wide hearth of 1" square ceramic tile; wooden mantle .

Fireplace: brick; 4' hearth of undetermined material; firebox depth, 1'9"; firebox closed with brick; wooden mantle .
